Debris/Ice/TPS Assessment and Integrated Photographic Analysis of Shuttle Mission STS-83

**DEBRIS/ICE/TPS ASSESSMENT
AND
INTEGRATED PHOTOGRAPHIC ANALYSIS
OF
SHUTTLE MISSION STS-83**

4 April 1997

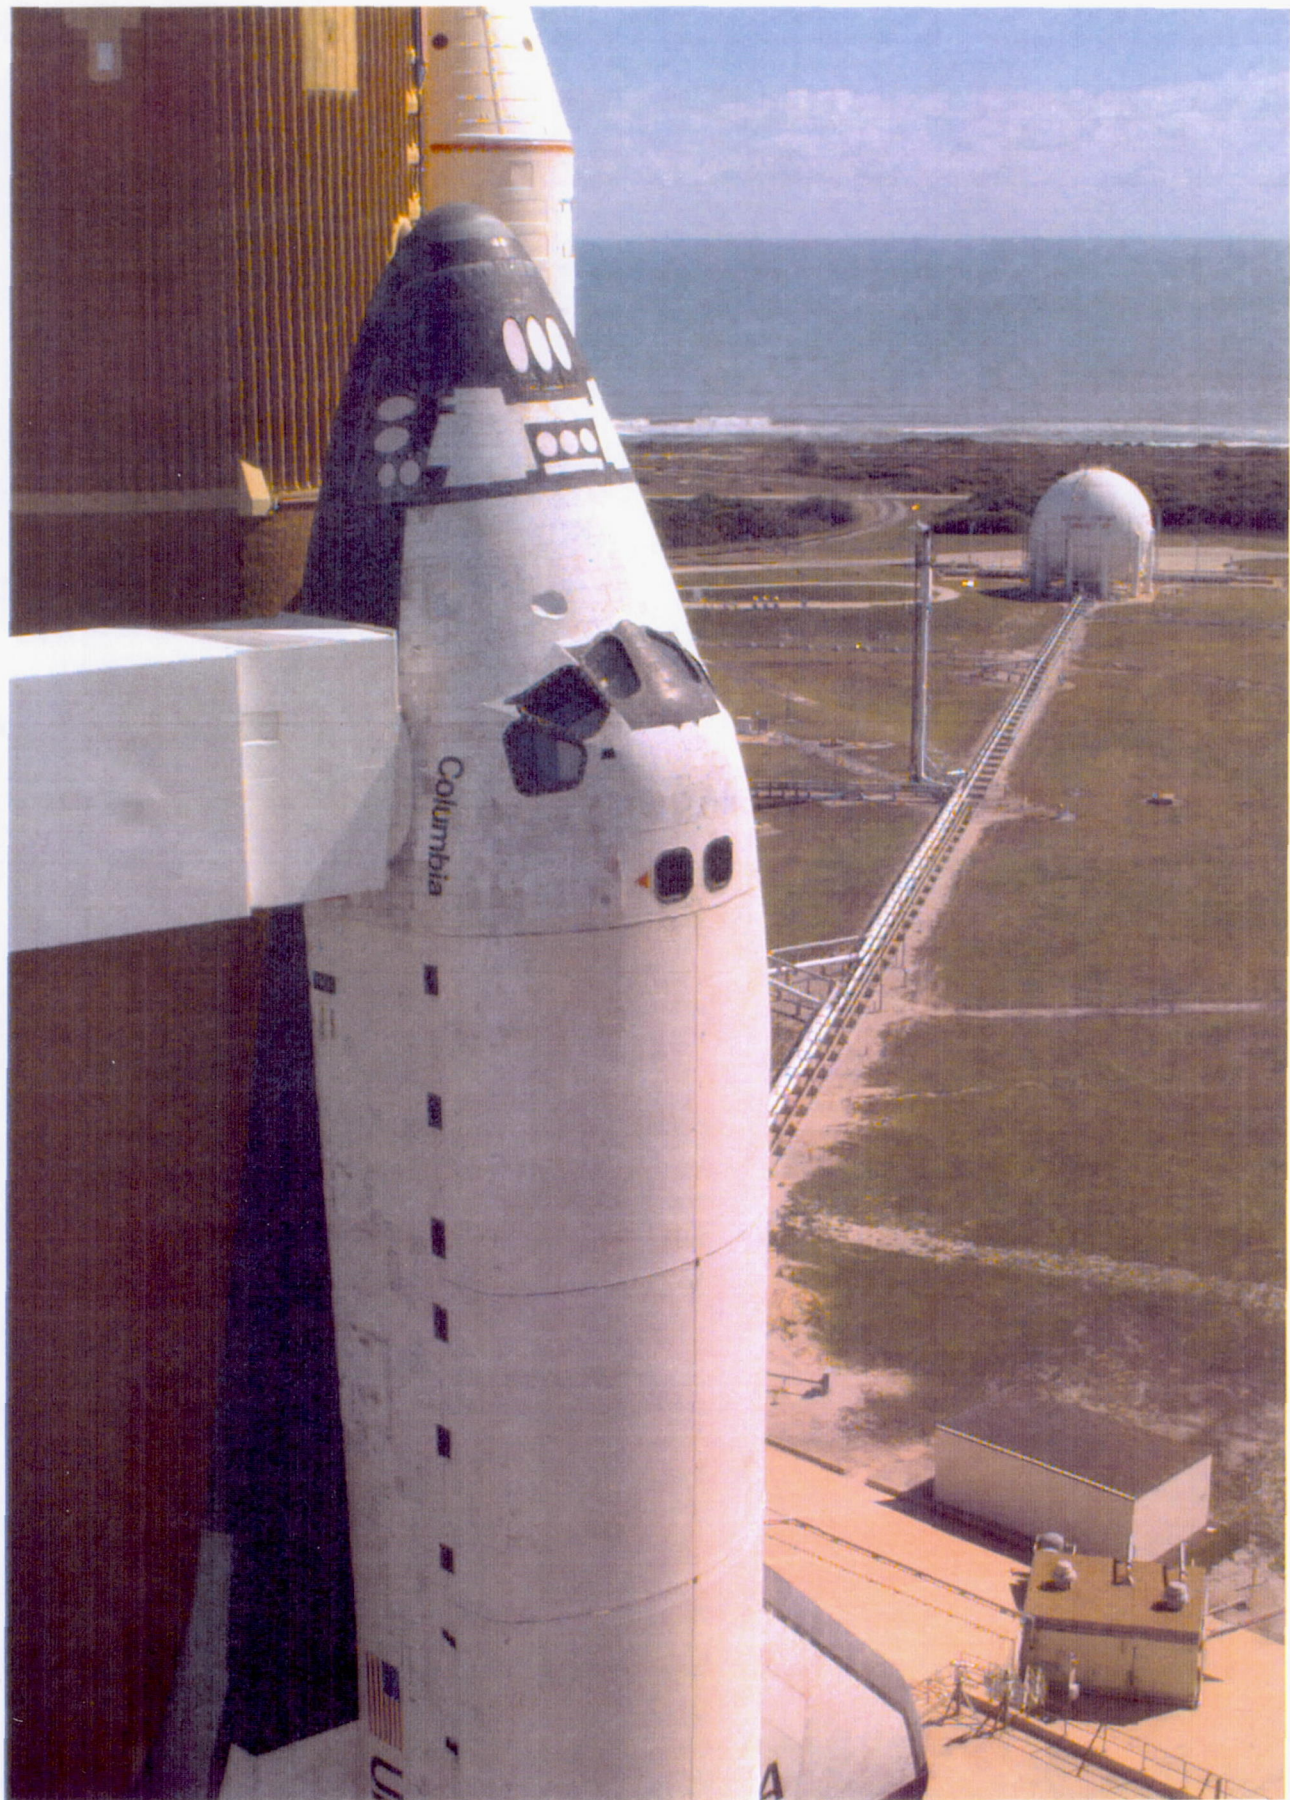
Photo 2: STS-83 Ready for Launch

OV-102 (22nd flight), ET-84 (LWT 77), BI-086 SRB's

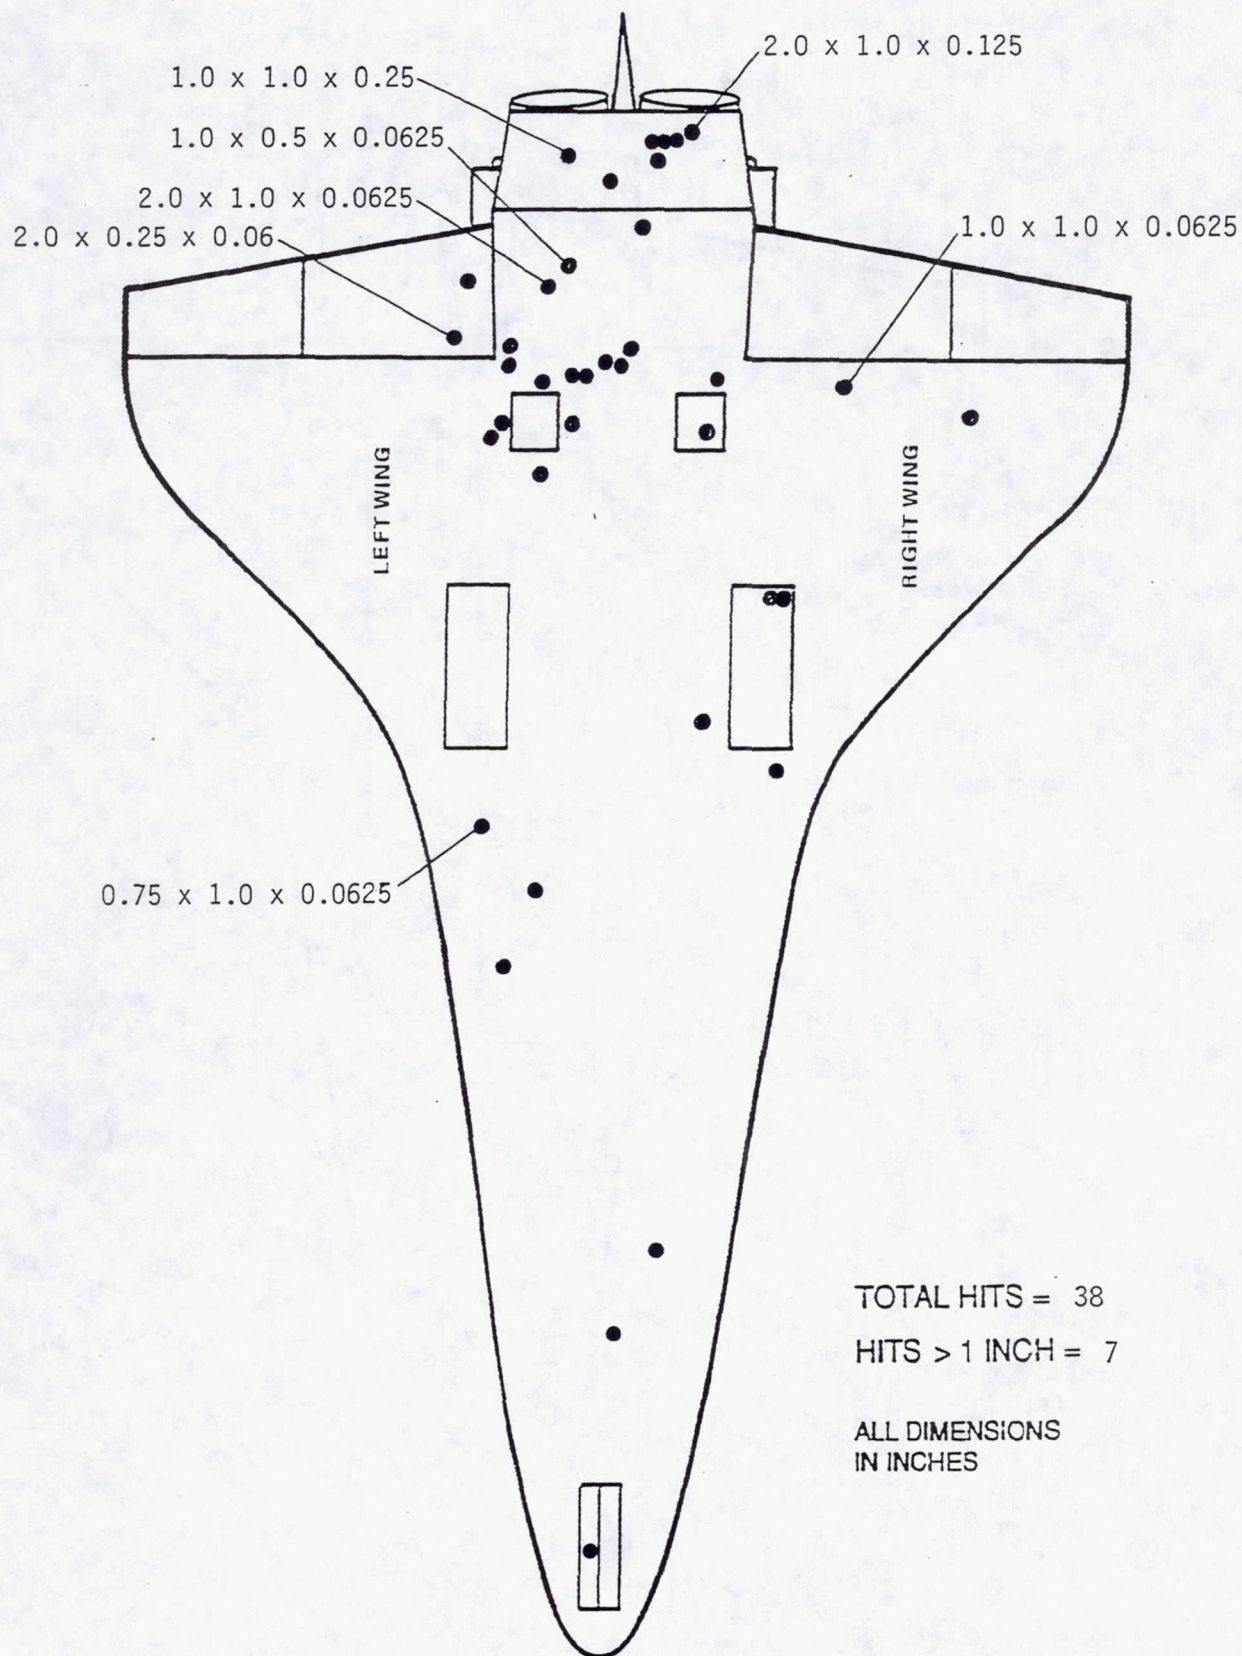
Figure 1: Orbiter Lower Surface Debris Damage Map

The Orbiter lower surface sustained a total of 38 hits, of which 7 had a major dimension of 1-inch or larger. The largest lower surface tile damage site was located on the body flap. The site measured 2-inches long by 1-inch wide by 0.125-inch maximum depth. The damage was probably caused by an impact from ET/ORB umbilical ice.

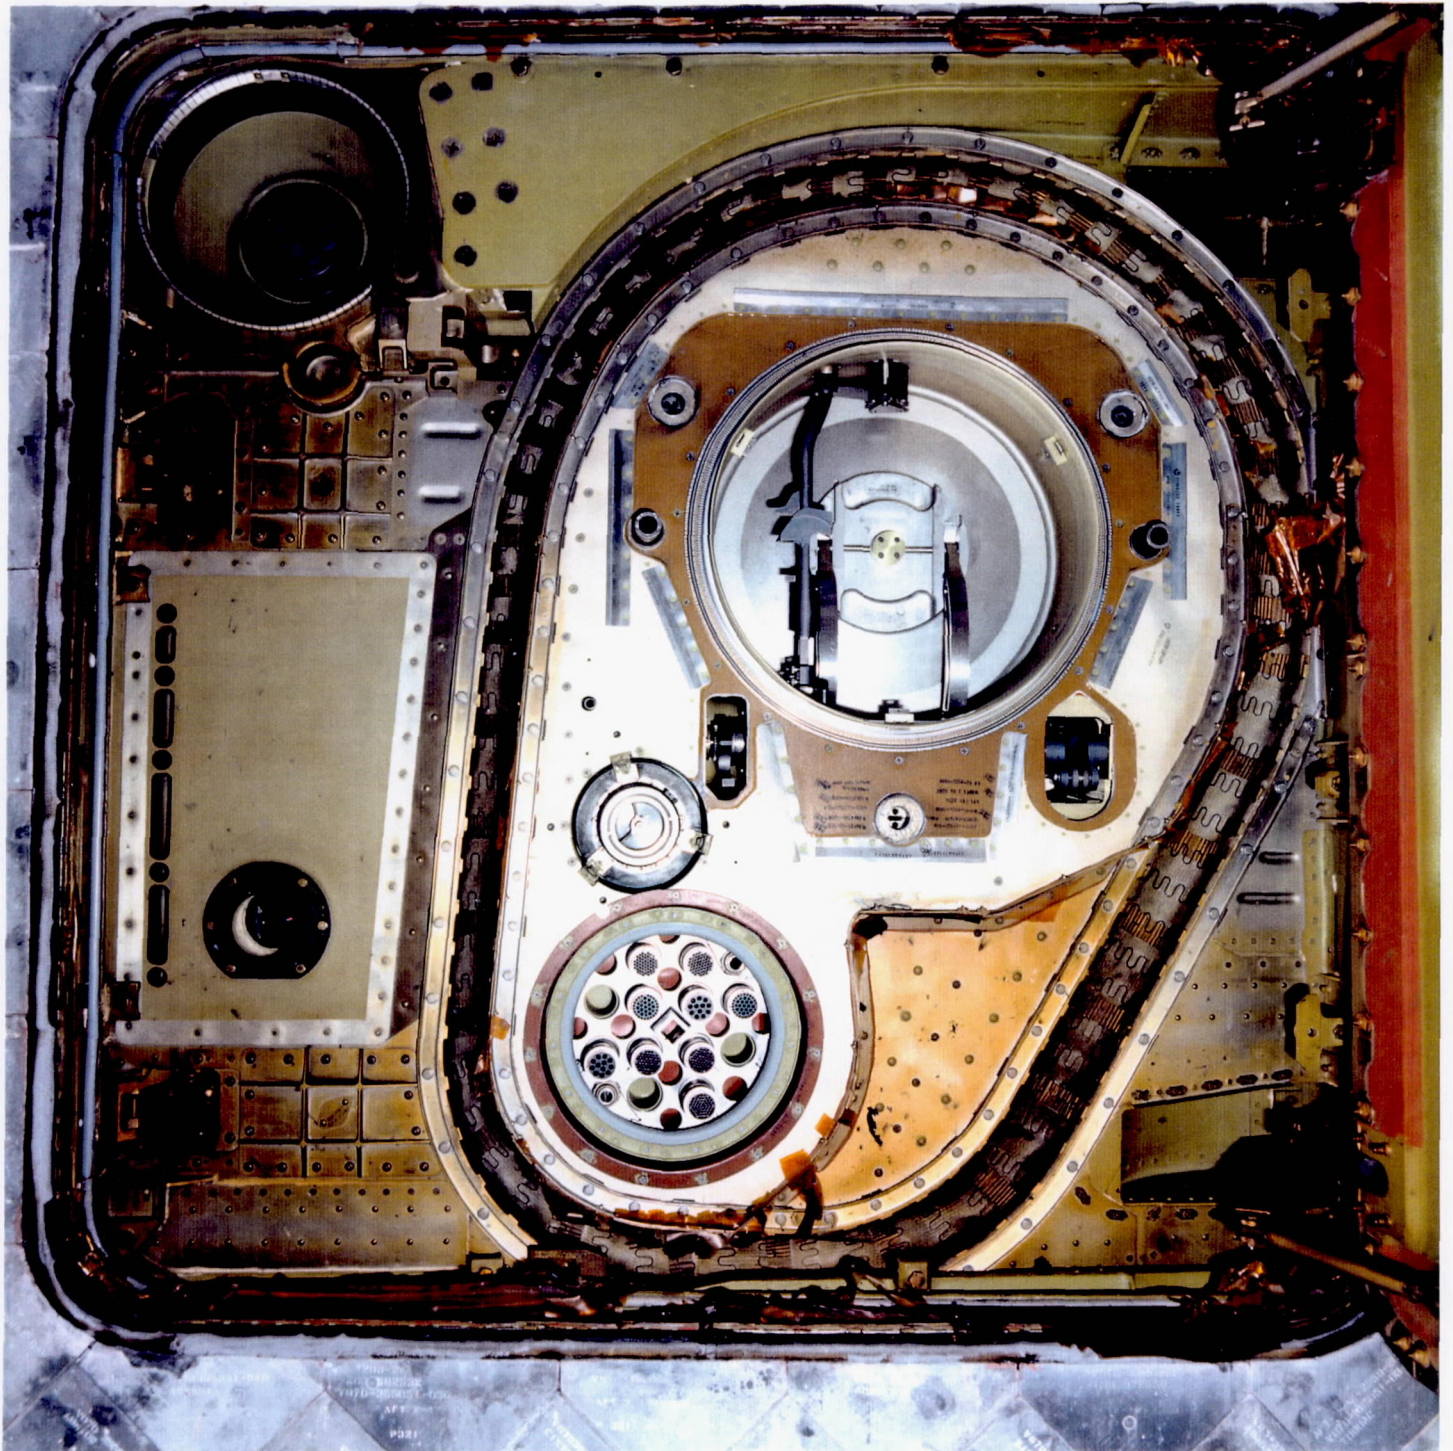
Photo 24: LO2 ET/ORB Umbilical

Bent metal, approximately 1-inch in length by 1/4-inch wide, was visible on the trailing edge of a spacer between two bolt heads on the inside surface of the LO2 ET door near the forward outboard corner. This same condition has occurred after the last three flights on different Orbiters.

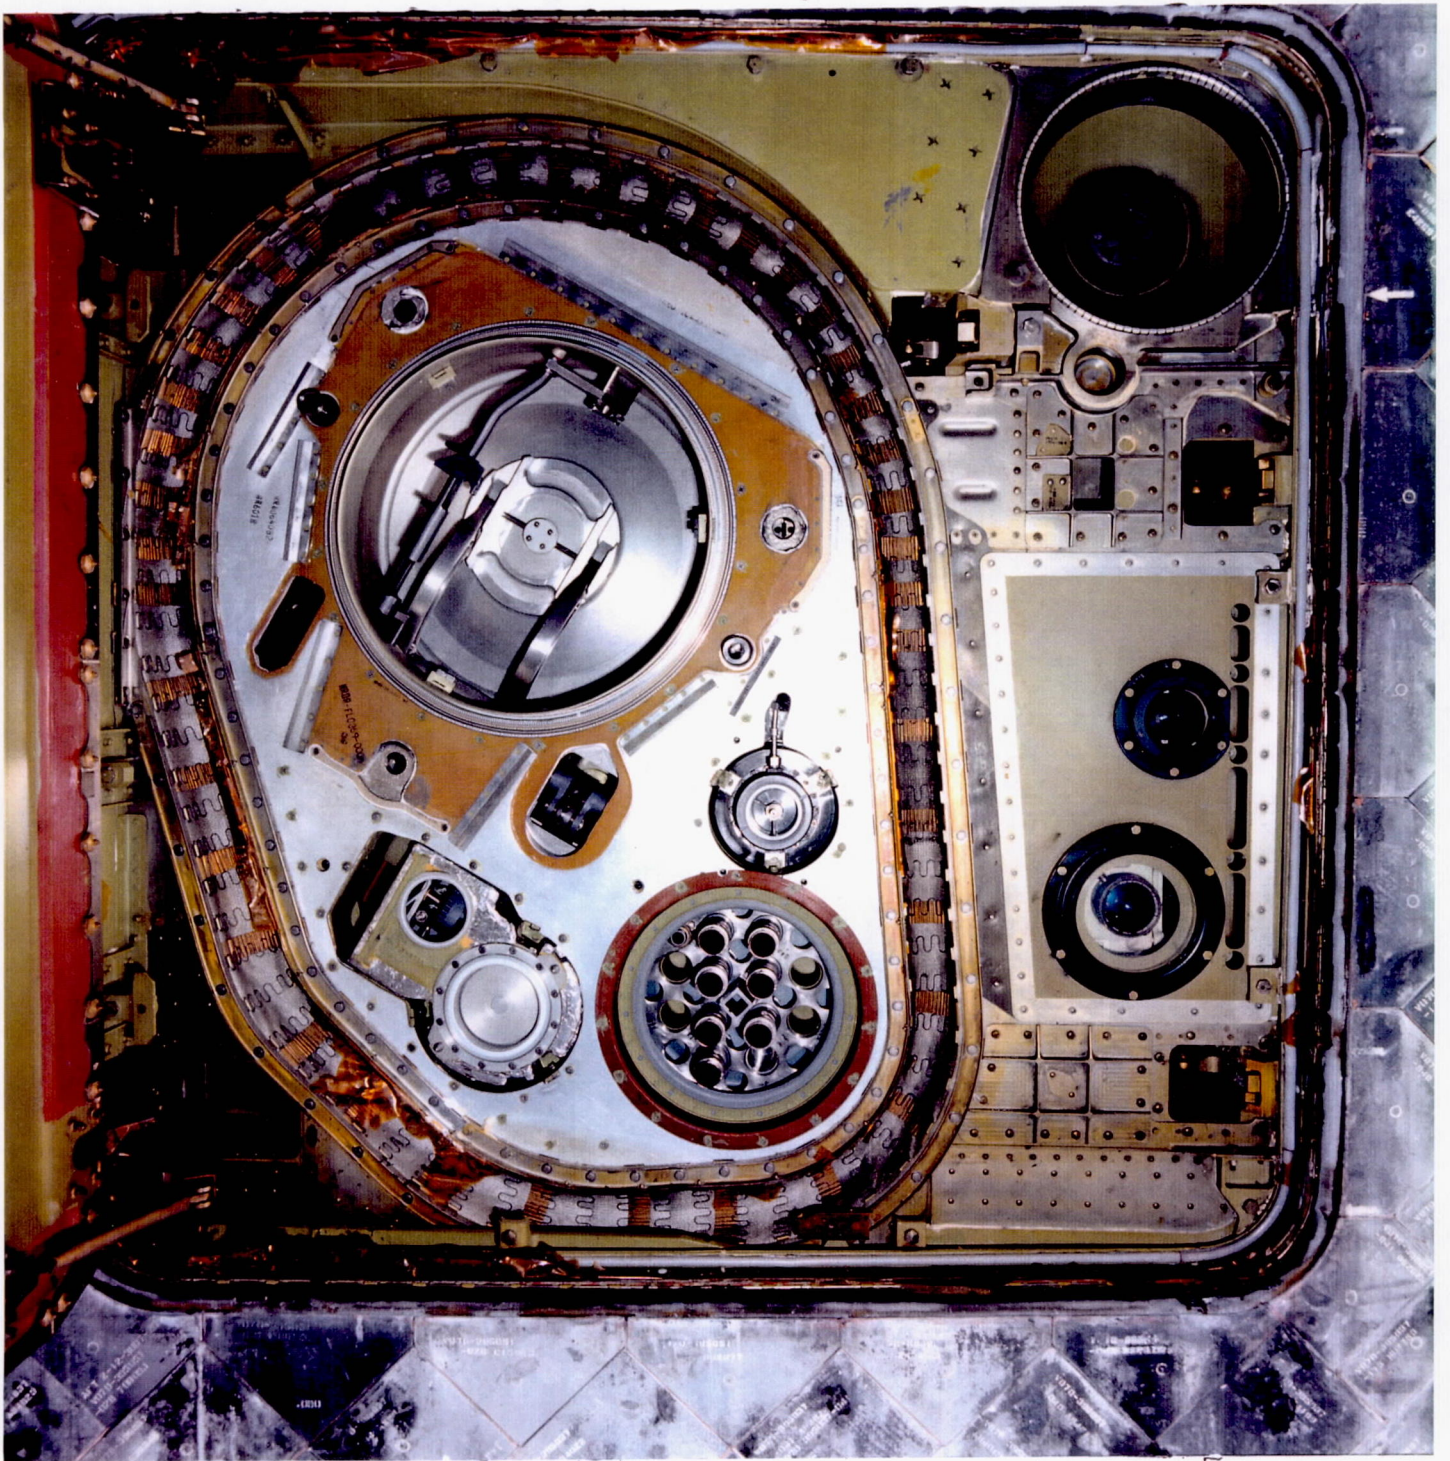
Photo 25: LH2 ET/ORB Umbilical

The LH2 ET/ORB umbilical appeared to be in good condition after separation with no TPS damage. Frozen hydrogen adhered to the 17-inch disconnect and parts of the separation interface. The fire barrier on the outboard side of the LH2 umbilical exhibited two unusually large bubbles that were estimated to be 3" x 2" and 6" x 2", respectively. Typically, foam had eroded from the horizontal (clamshell) section of the cable tray.

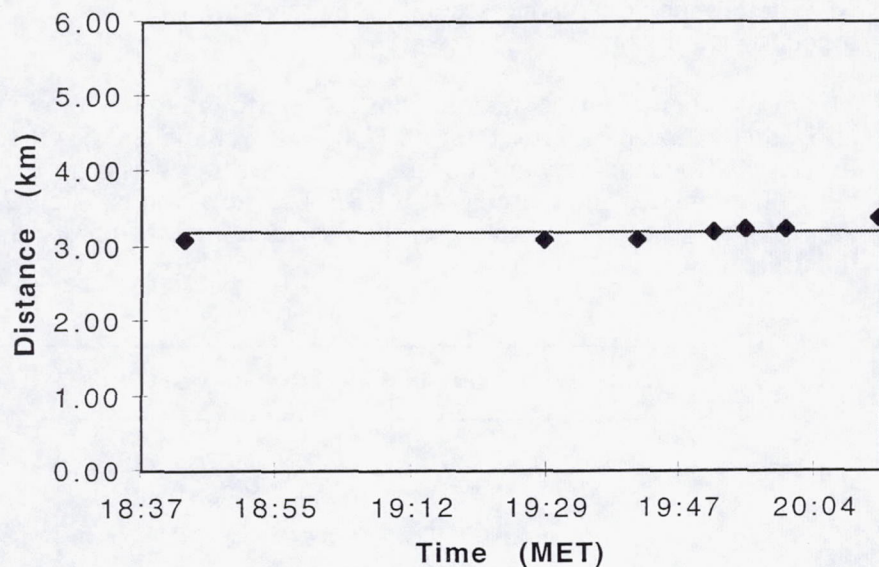
Figure 2.5.2 ET Separation Velocity

The distance of the external tank was calculated on eight frames. On the first usable view, the external tank was calculated to be a distance of 3.1 km away from the Orbiter at 18:43 MET. On the last view, the tank was calculated to be at a distance of 3.4 km (1.5 minutes after the first view). The tank separation average velocity was determined to be 3.5 meters/second (m/s), with an uncertainty of approximately 1 m/s. The tank tumble rate was approximately 0.5 degrees/second and the roll rate was approximately 0.6 degrees/second.

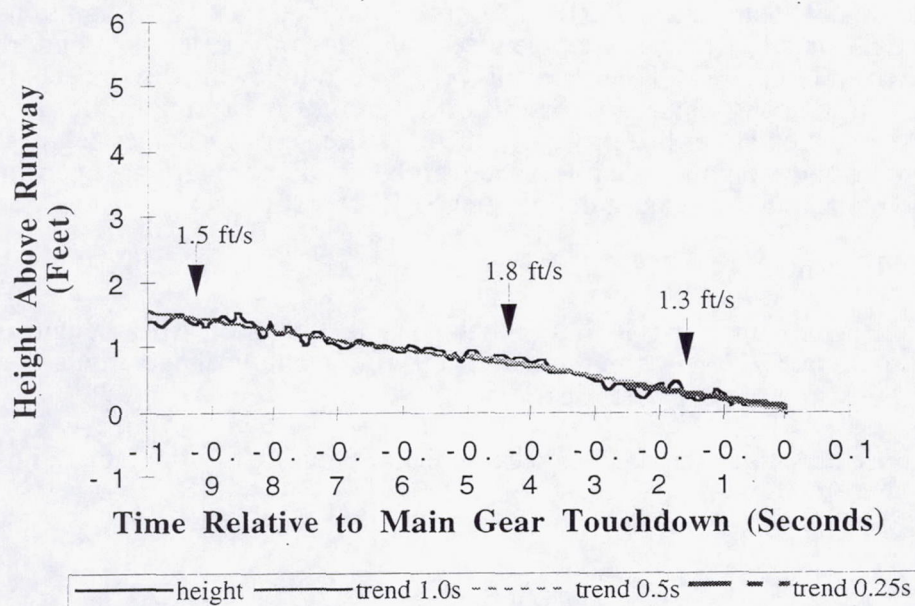
Figure 2.6.1 (A) Main Gear Height versus Time Prior to Touchdown

The measured main gear sink rate values were found to be below the maximum allowable values of 9.6 ft/sec for a 211,000 lb. vehicle and 6.0 ft/sec for a 240,000 lb. vehicle (the landing weight of the STS-83 Orbiter was reported to be 235,286 lbs.). The sink rate measurements for STS-83 are given in Table 2.6.1. In Figure 2.6.1(A), and 2.6.1(B), the trend of the measured data points for the image data is illustrated.
